**Client Name:** Preston  
Redevelopment Agency

**Site Location:** Former Norwich  
State Hospital, Ribicoff Building

**Project No.** 250598

**PHOTOGRAPHIC LOG**

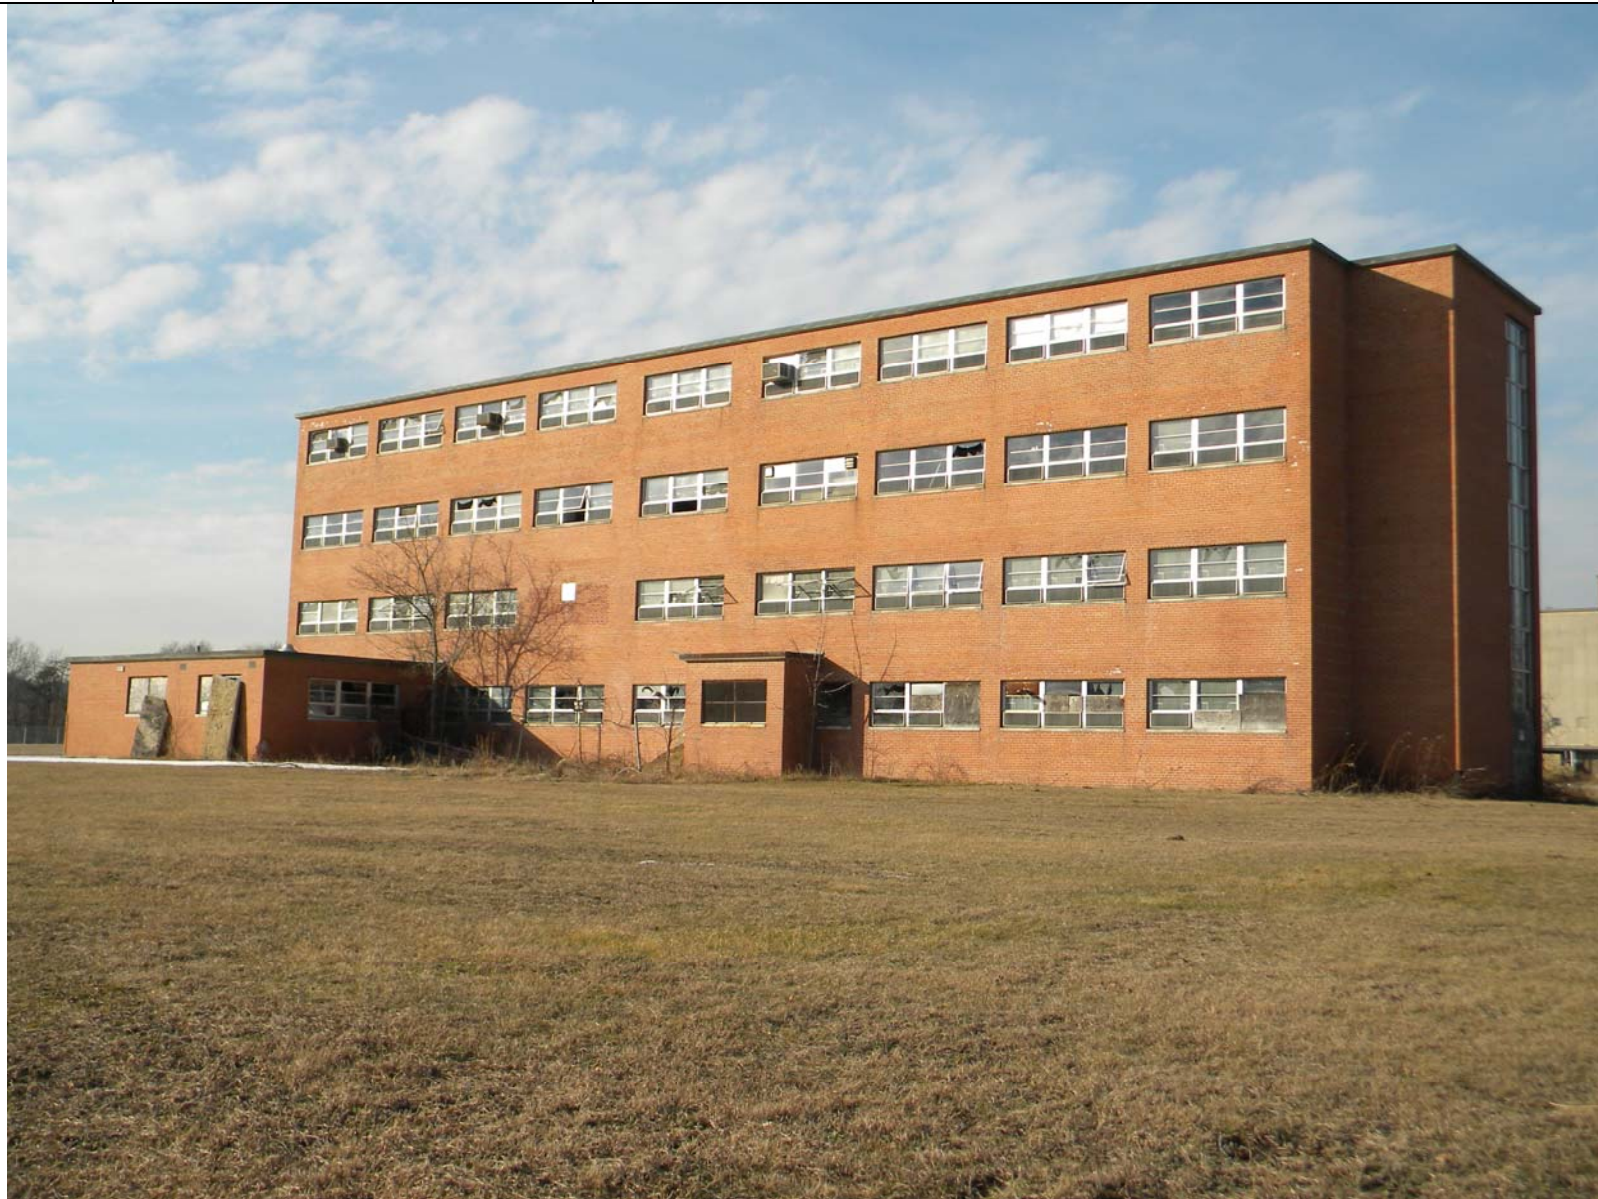
**Photo No.**  
2

**South Side of Building  
(Side C)**

**Back of building**

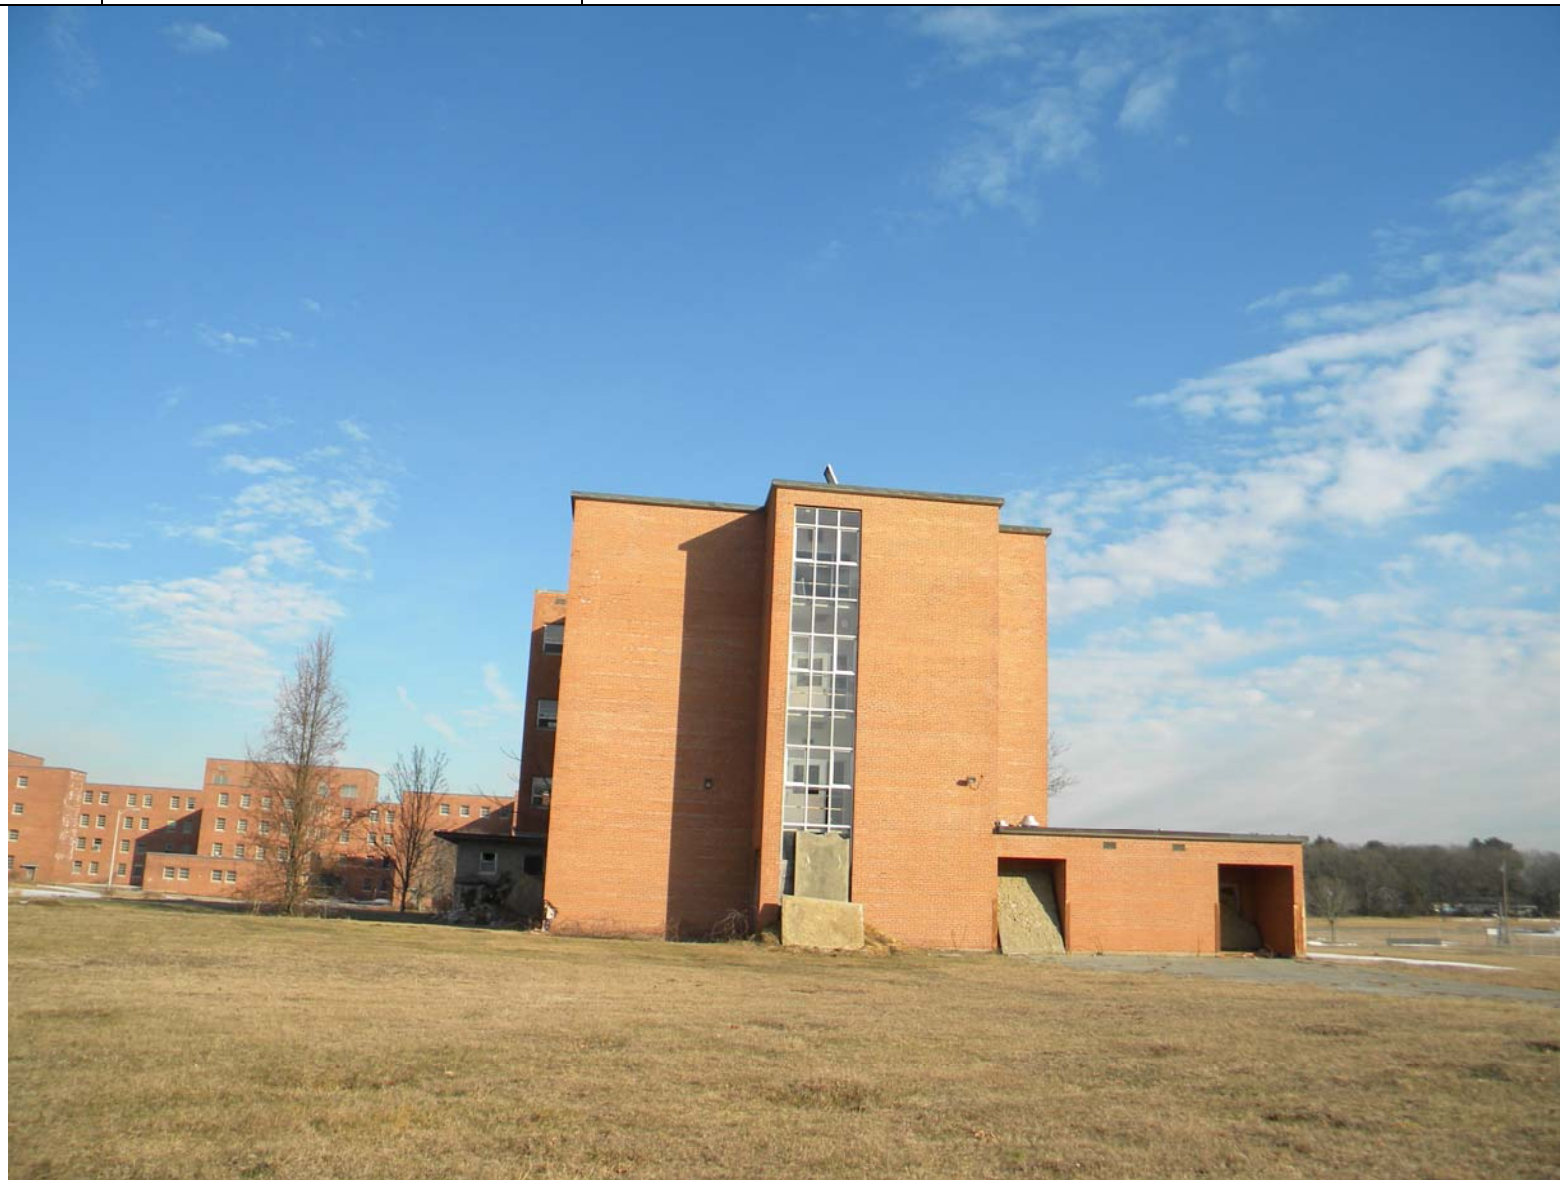
**Client Name:** Preston  
Redevelopment Agency**Site Location:** Former Norwich  
State Hospital, Ribicoff Building**Project No.** 250598**Photo No.**  
3 **Date:**  
June 2012**Photo Taken of:****West Side of Building  
(Side D)****Description:****Side of building with  
window having caulk  
contacting >50 ppm  
PCBs**

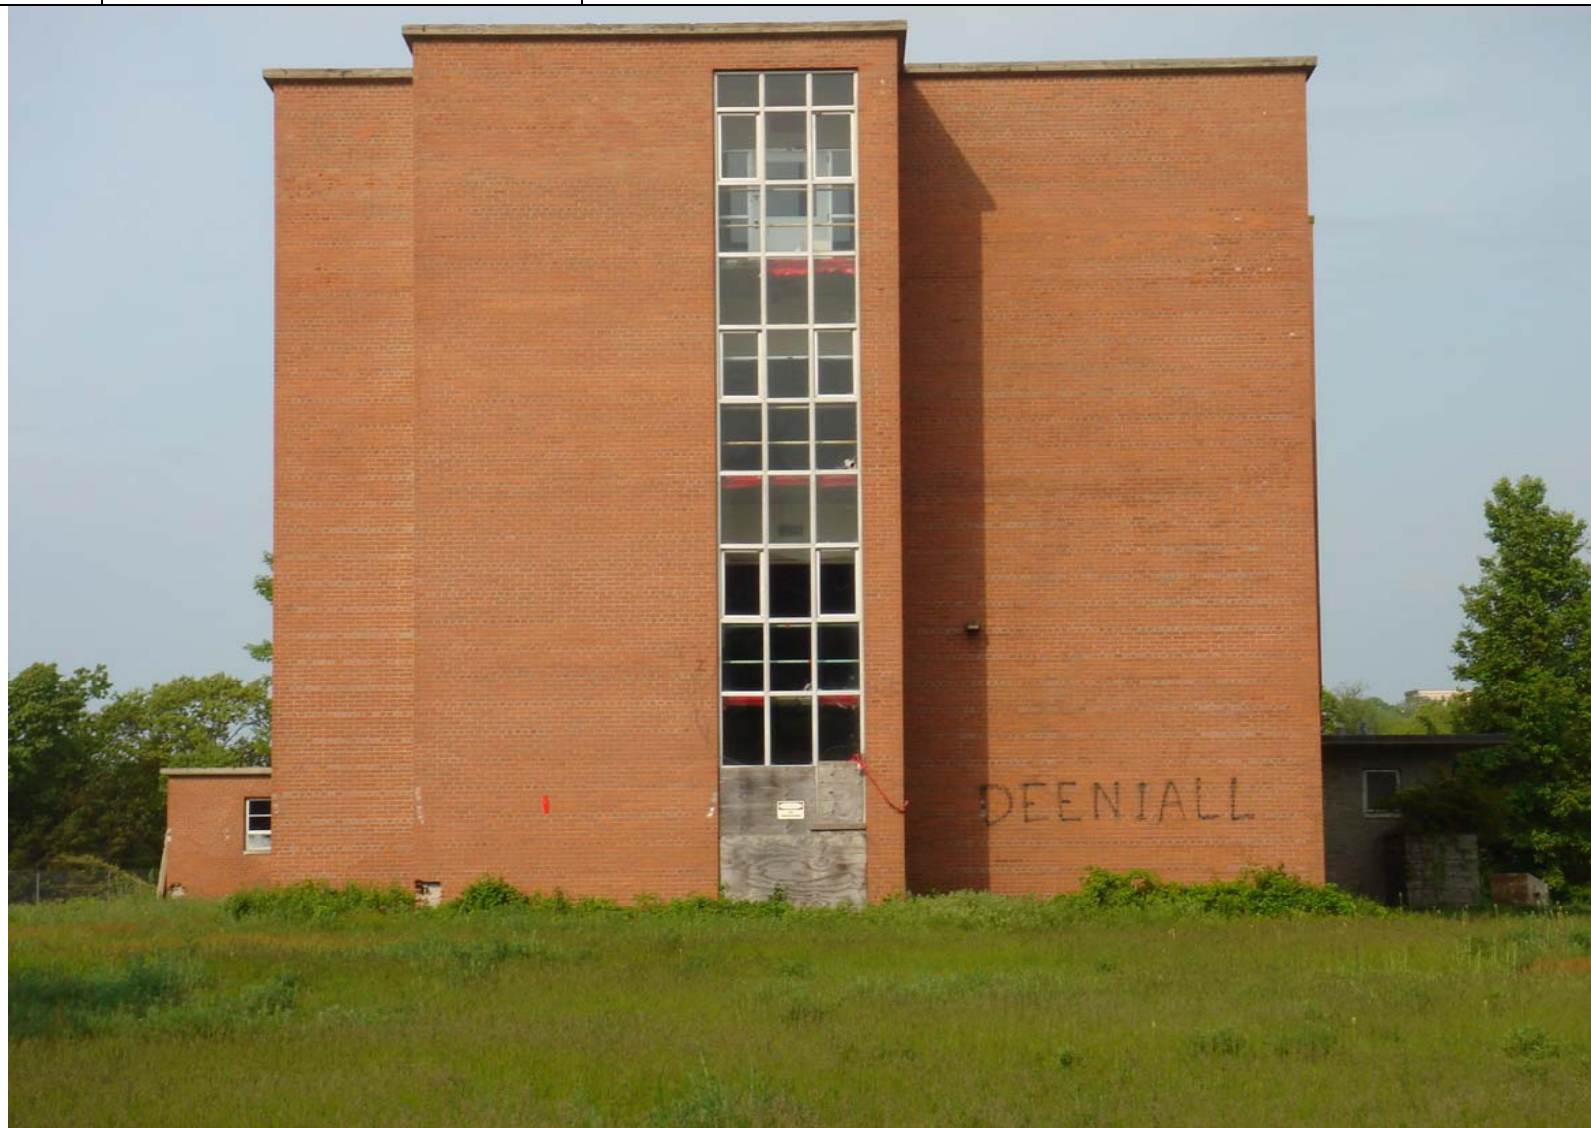
**Photo No.**  
4 **Date:**  
June 2012

**East Side of Building  
(Side B)**

East side of building  
with curtain wall type  
window systems having  
caulk less than 50ppm  
PCBs.

Exception is the small  
window on the one  
story portion in the  
lower left side of the  
photo. This window  
contains caulk with >  
50ppm PCBs and will be  
disposed along with  
windows from the front  
and rear sides of the  
building.

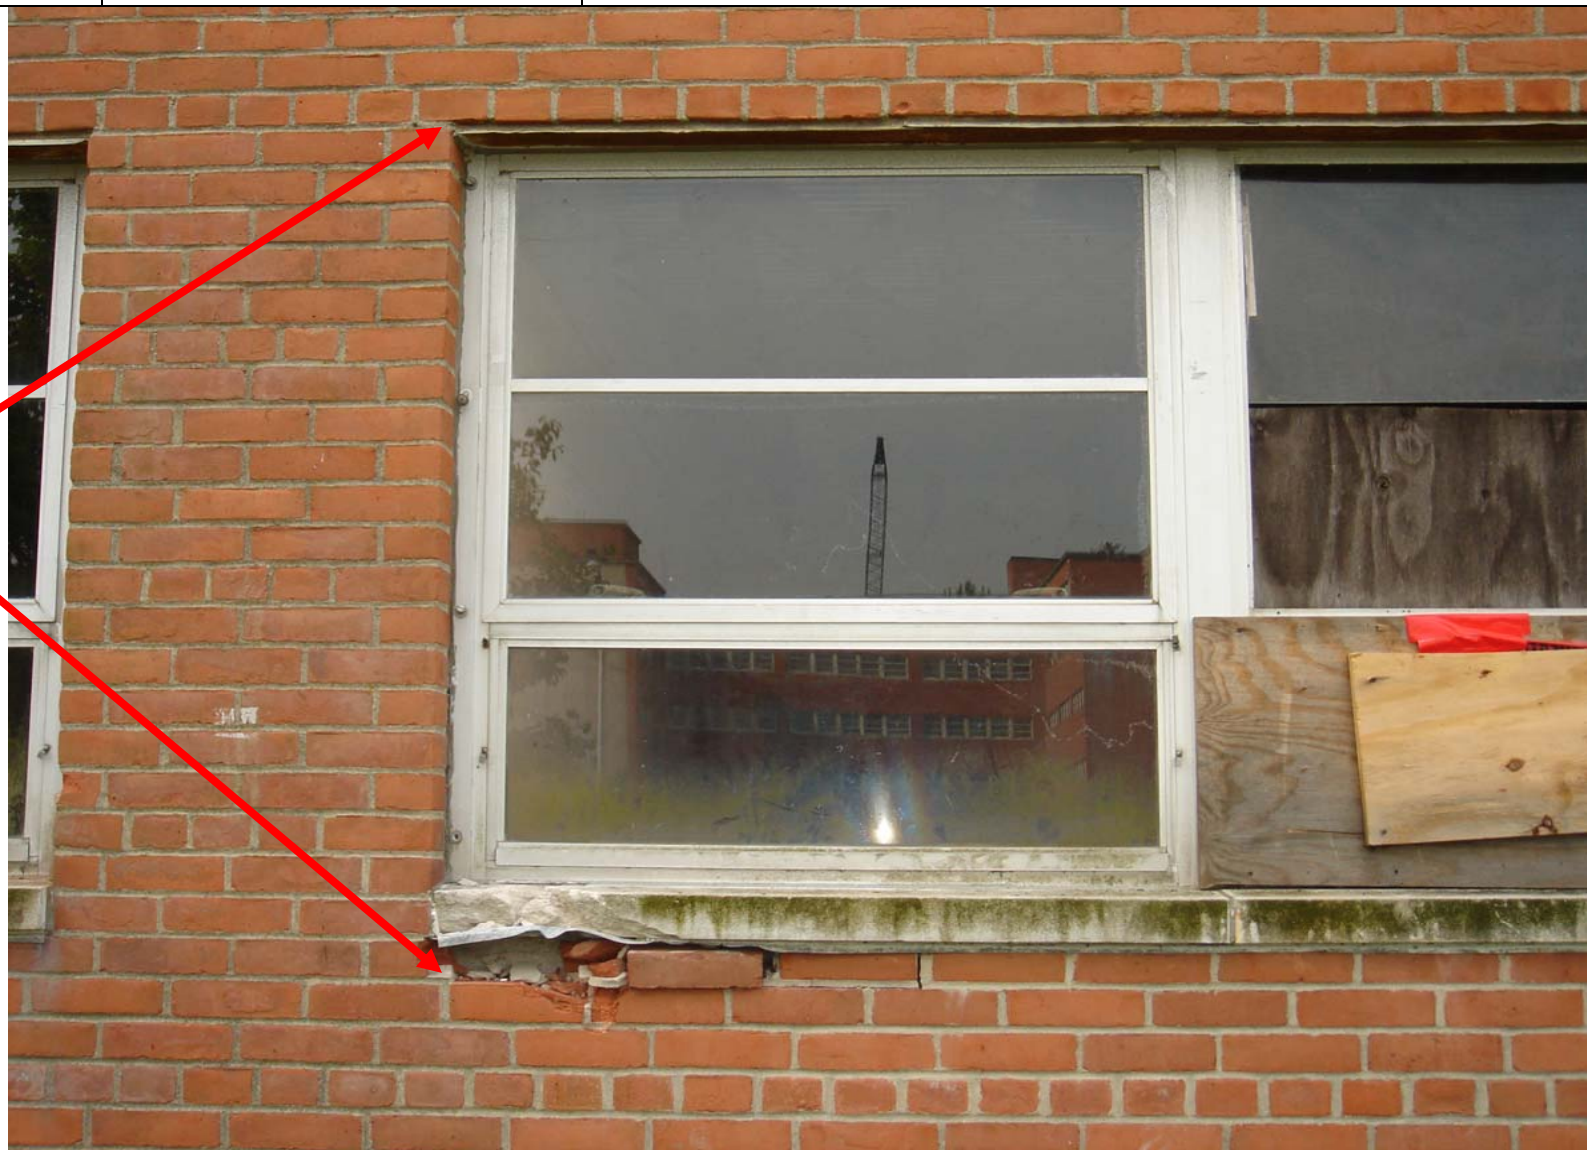
**Photo No.**  
5

**Window Detail**

View of front & rear  
windows having caulk  
containing > 50 ppm  
PCBs.

The metal lintel above  
the windows and metal  
flashing below sills  
separate window caulk  
from brick substrate  
above and below  
windows.

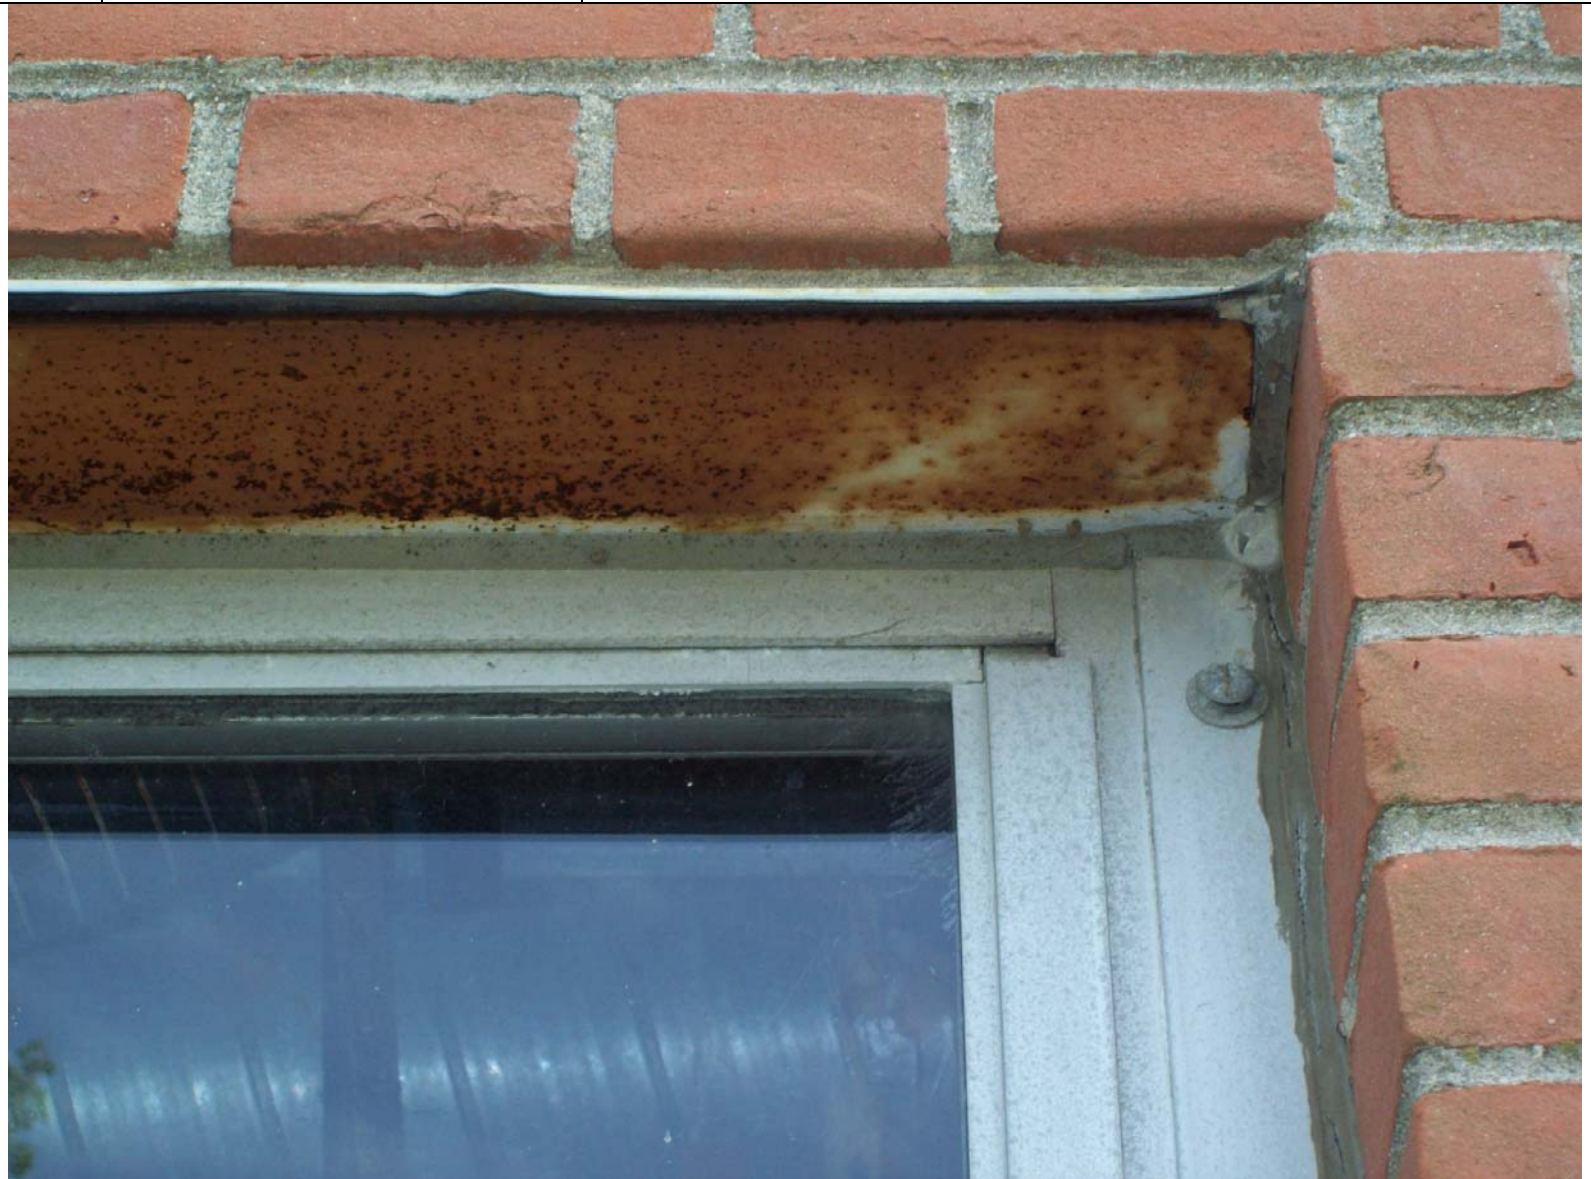
Photo No. 6  
Date: June 2012

Lintel Detail

Rusted Condition of  
Lintel

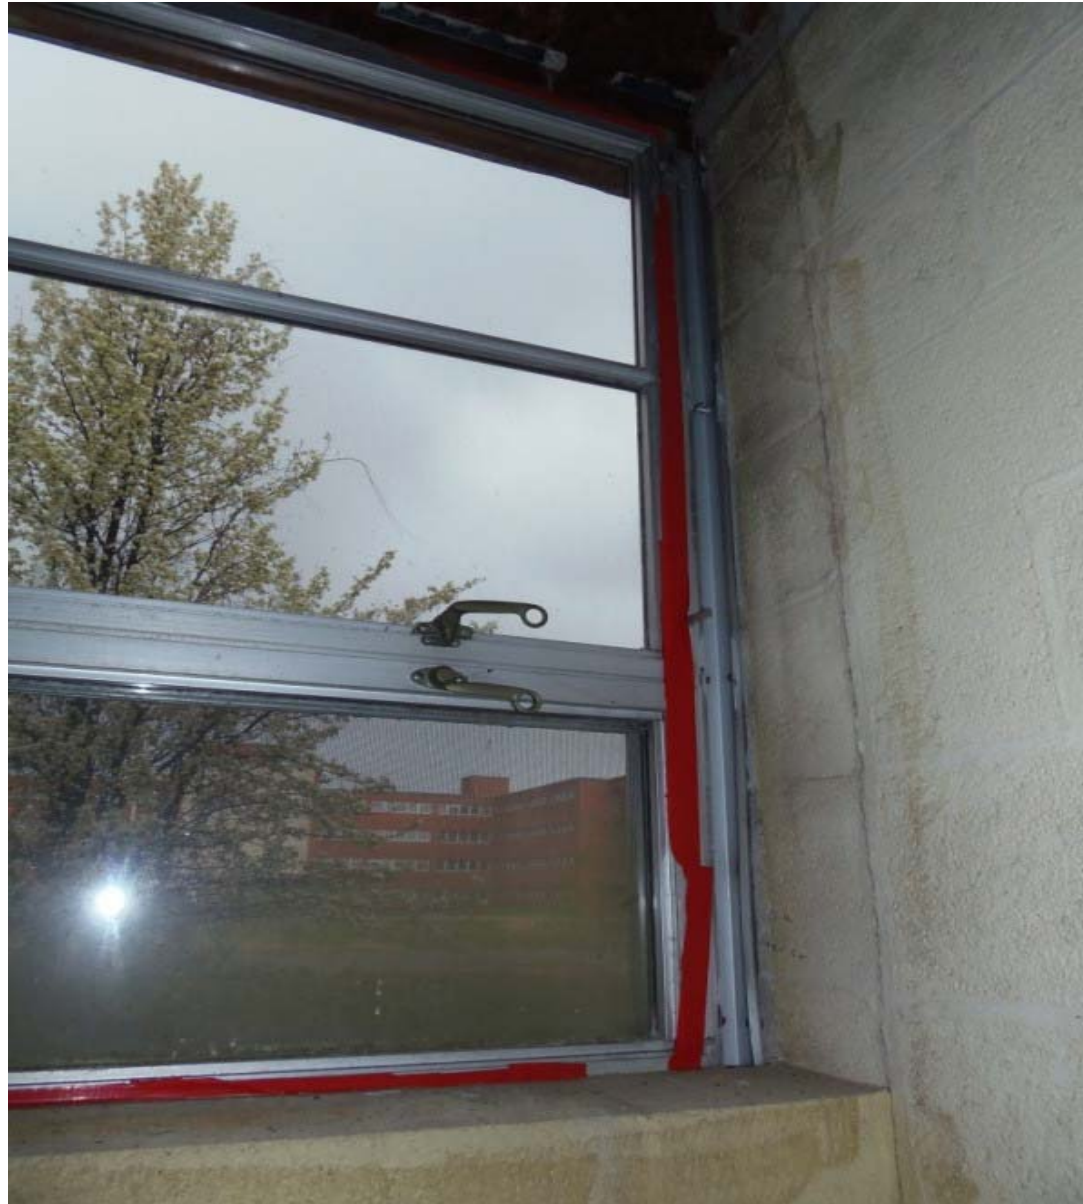
**Client Name:** Preston  
Redevelopment Agency**Site Location:** Former Norwich  
State Hospital, Ribicoff Building**Project No.** 250598**Photo No.**  
9 **Date:**  
June 2012**Photo Taken of:****Interior Window Side  
A & C****Description:****Interior View and  
glazing**

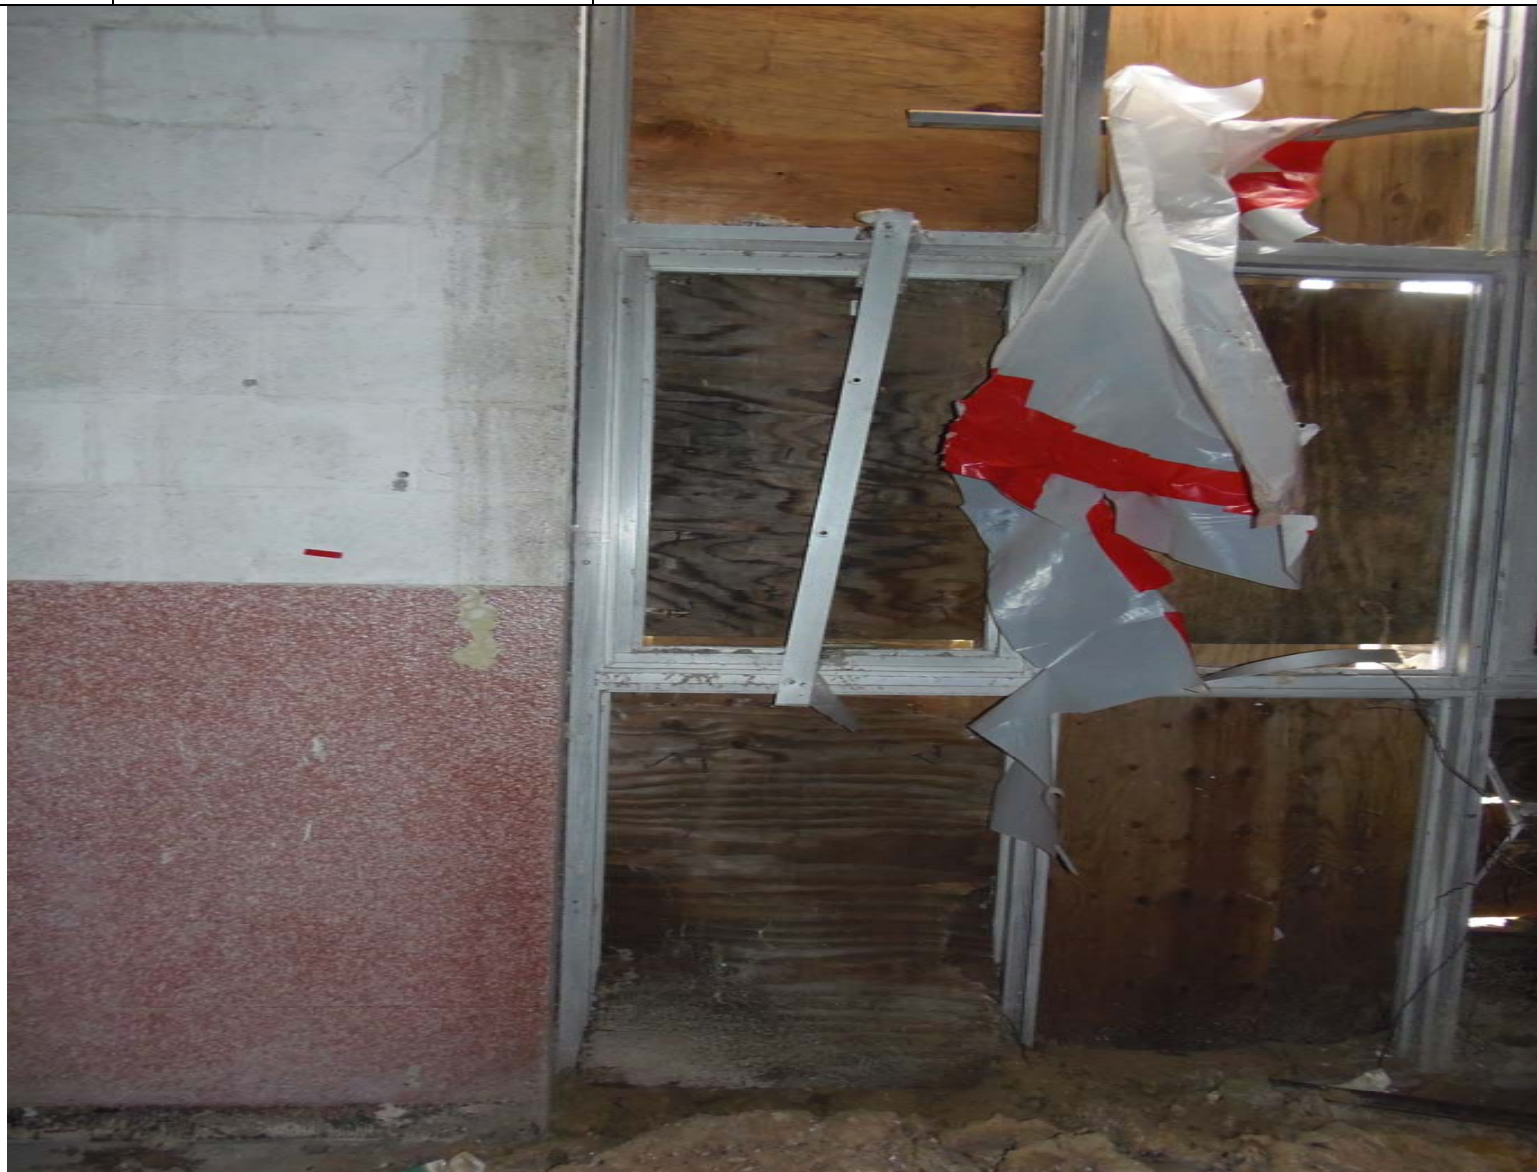
**Photo No.**  
10

**Exterior Window  
System Side B & D**

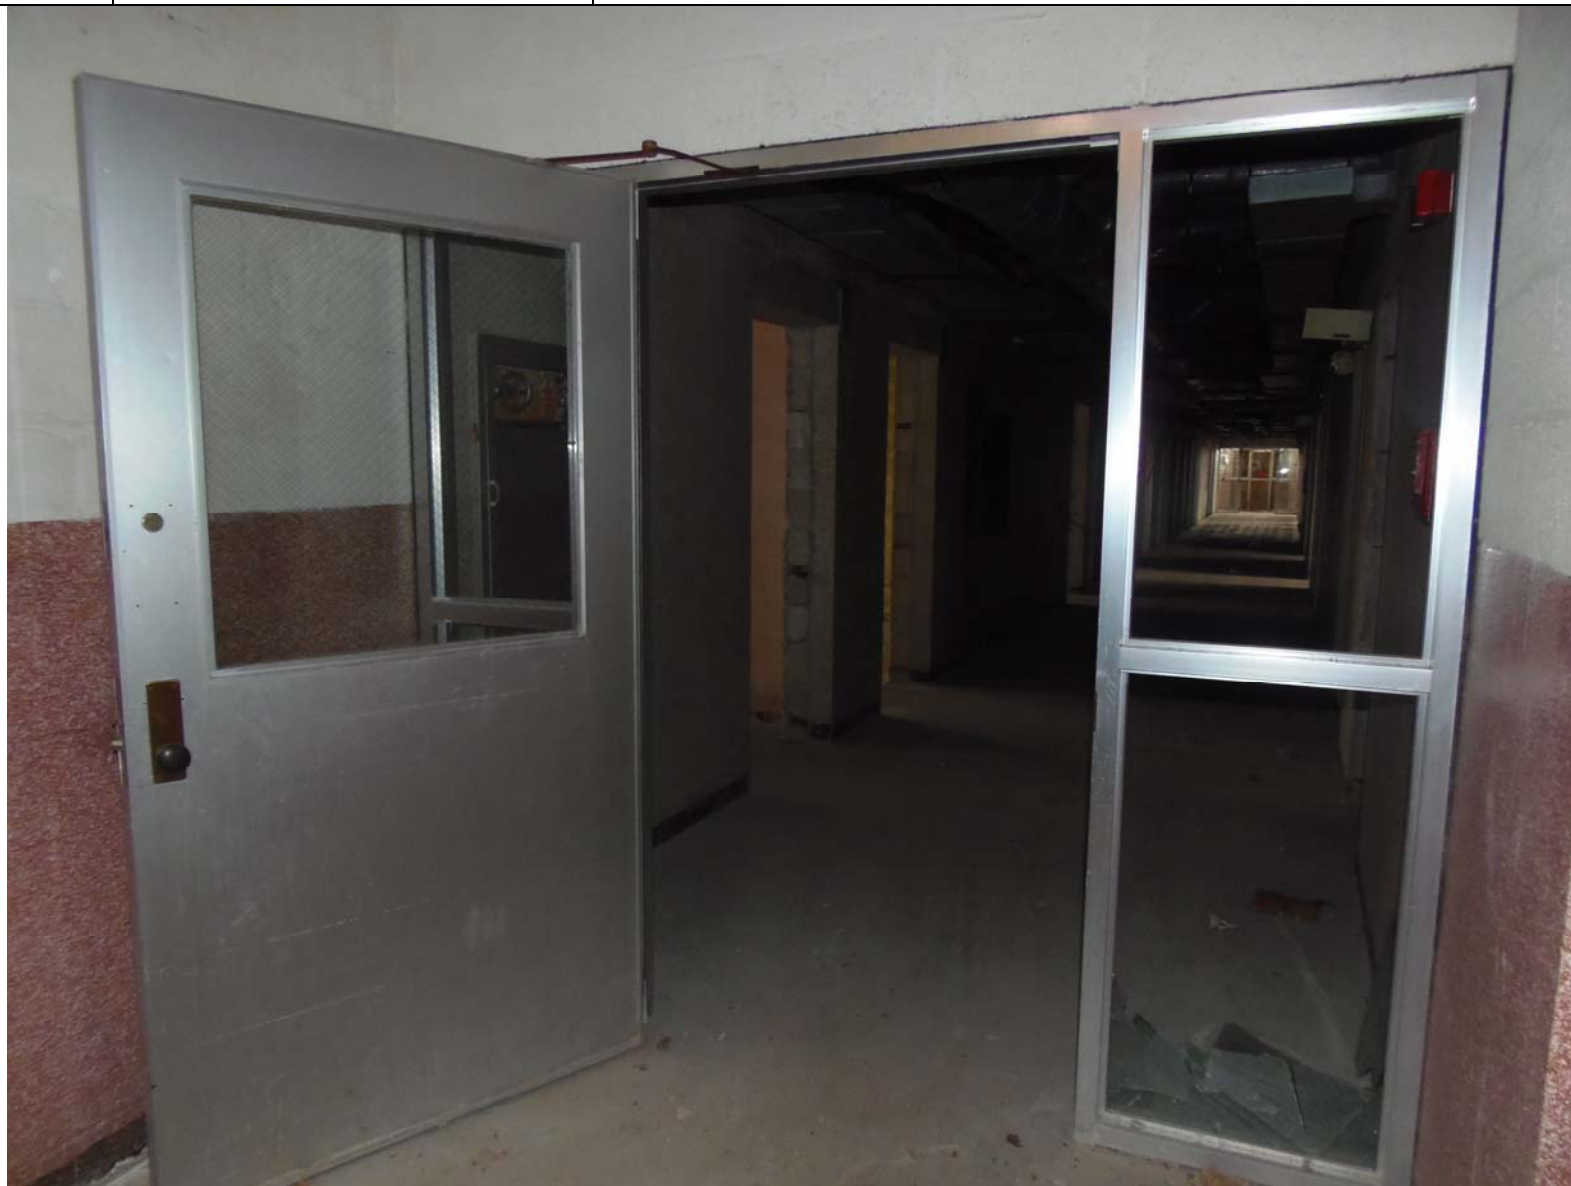
**Photo No.**  
11

Interior door/window  
system

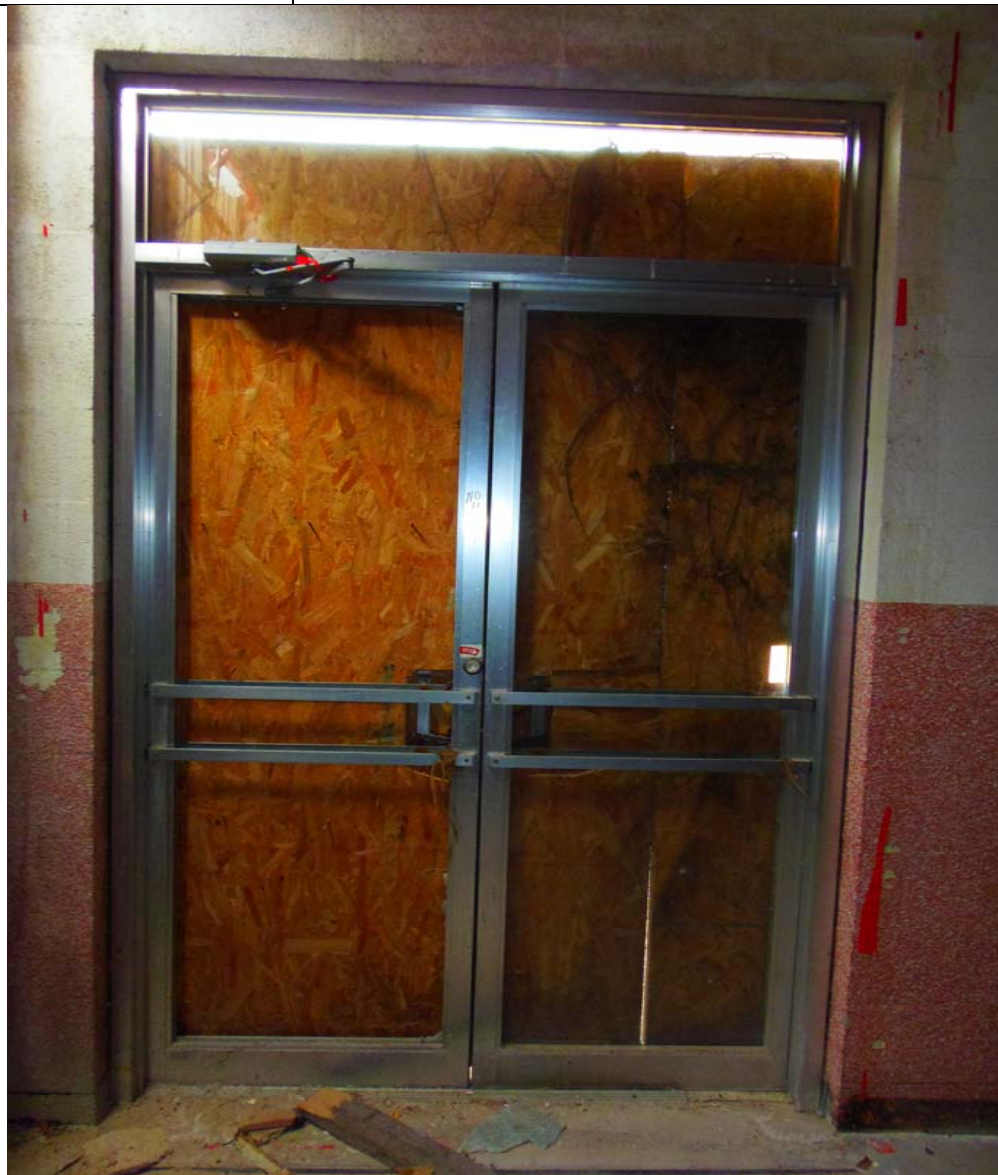
**Photo No.**  
12

**Interior Window/Door  
System**

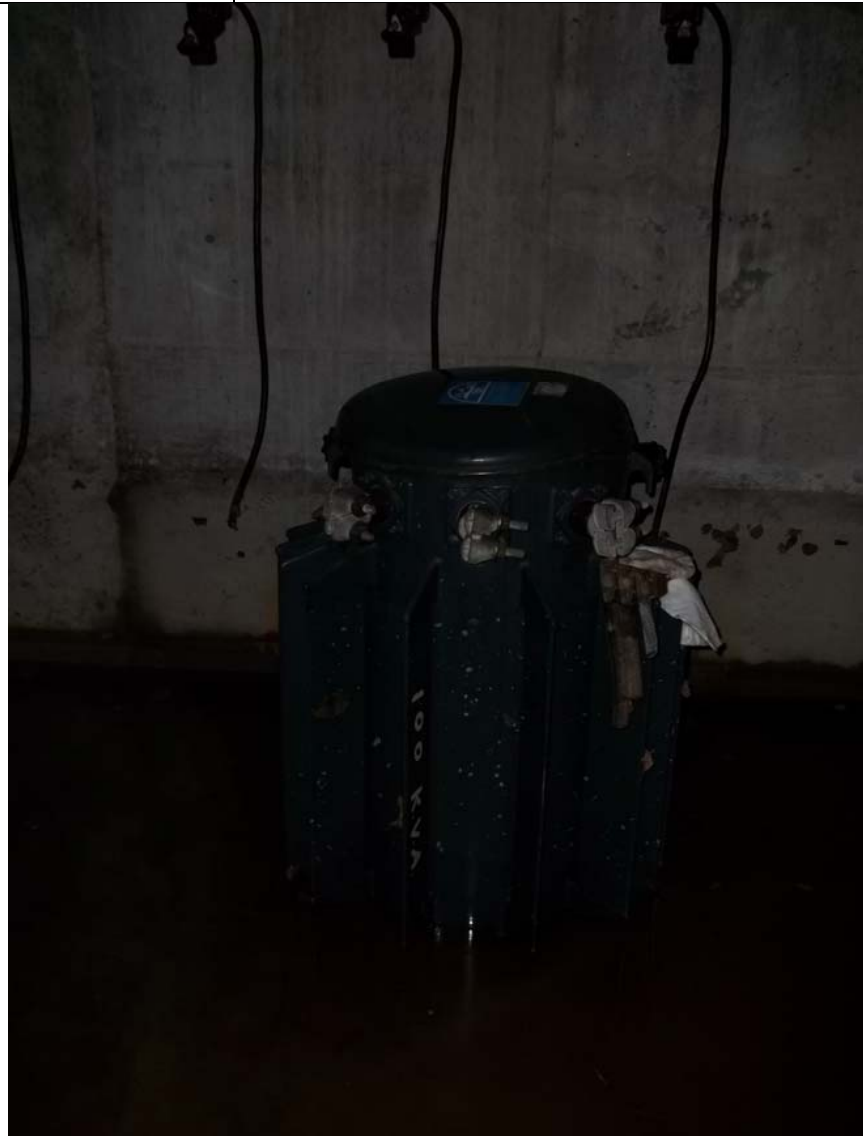
**Photo No.**  
13

**Photo Taken of:**  
Transformer Vault

Transformer

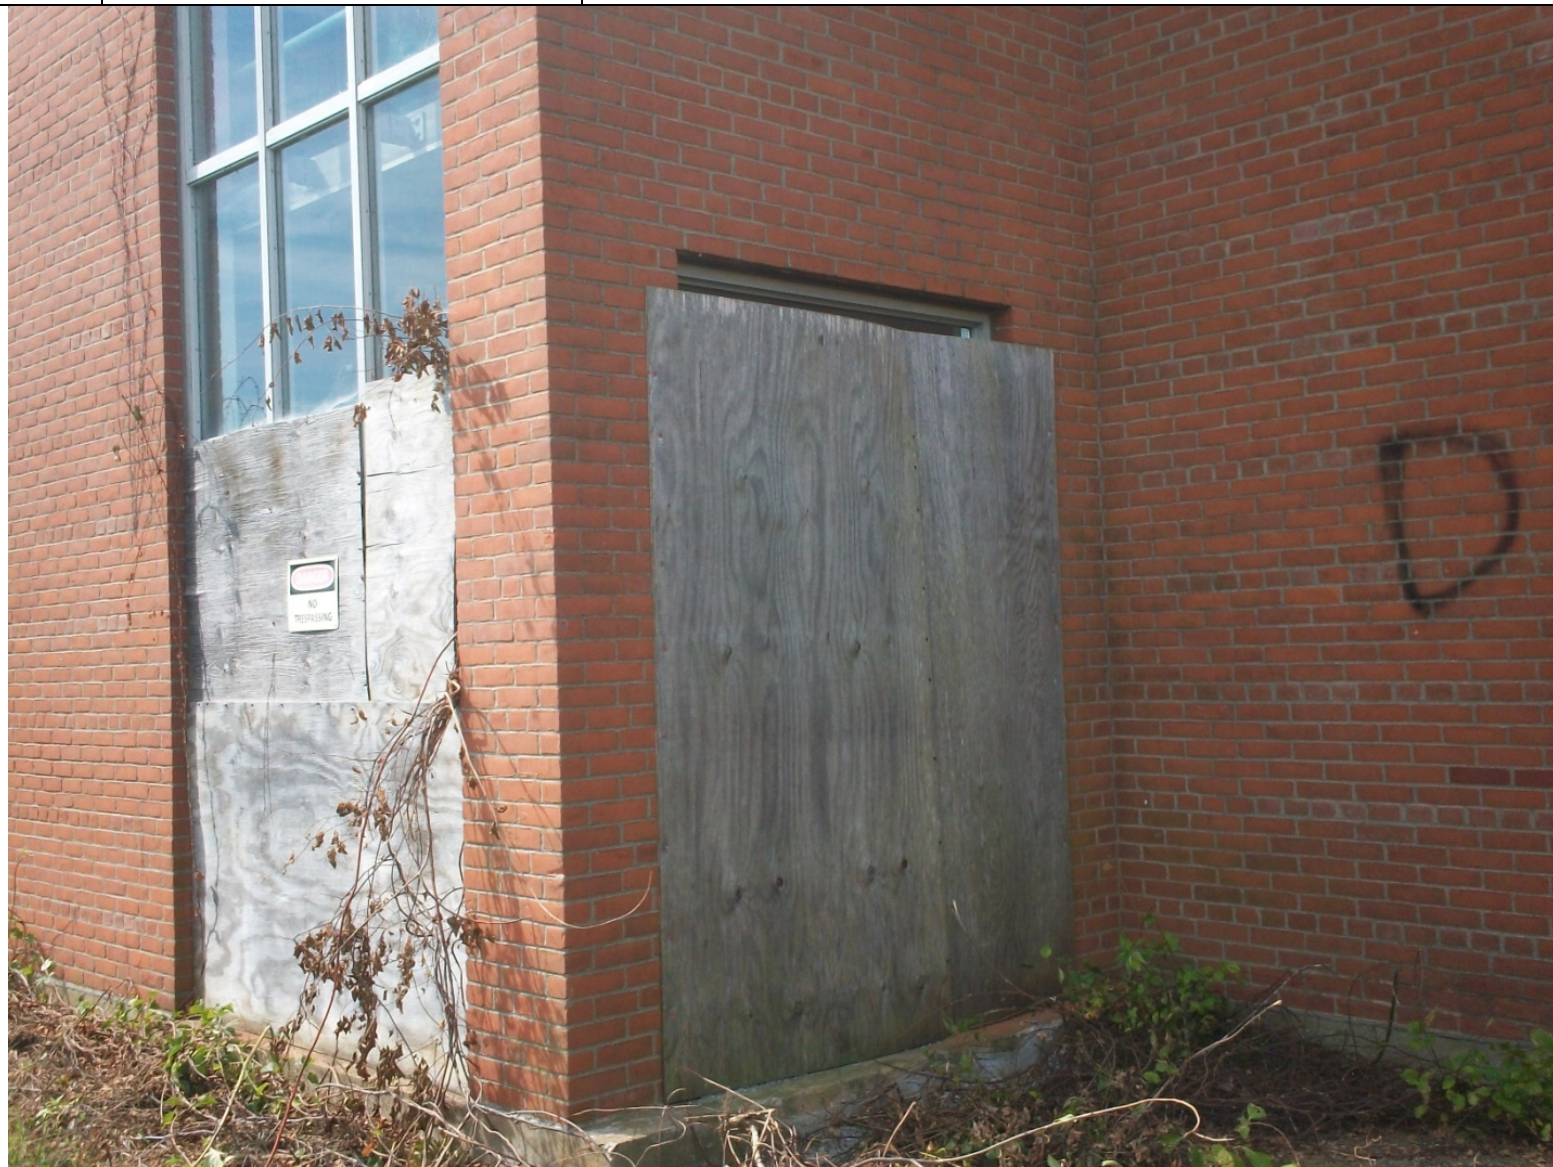
**Photo No.**  
14

**East Side (Side B) of  
Building**

**Door/Window System  
and Caulk**

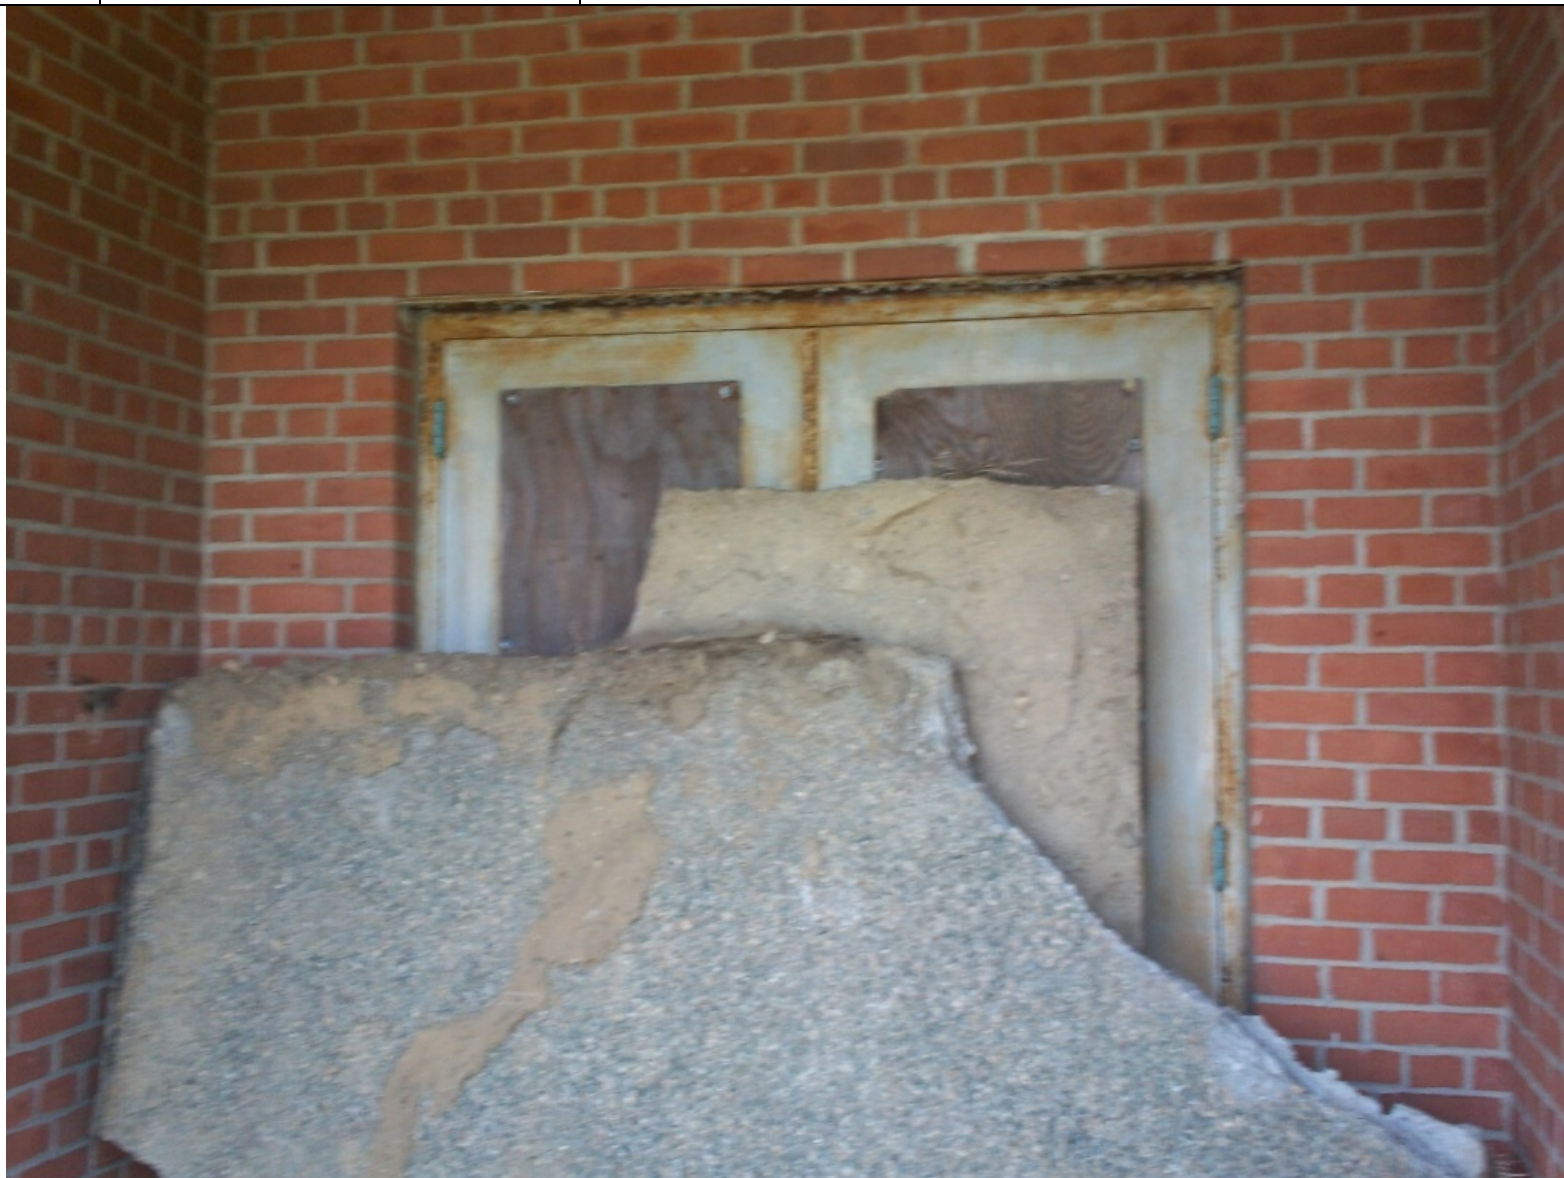
**Photo No.**  
15

**West Side of Building**

**Side Door Caulk**

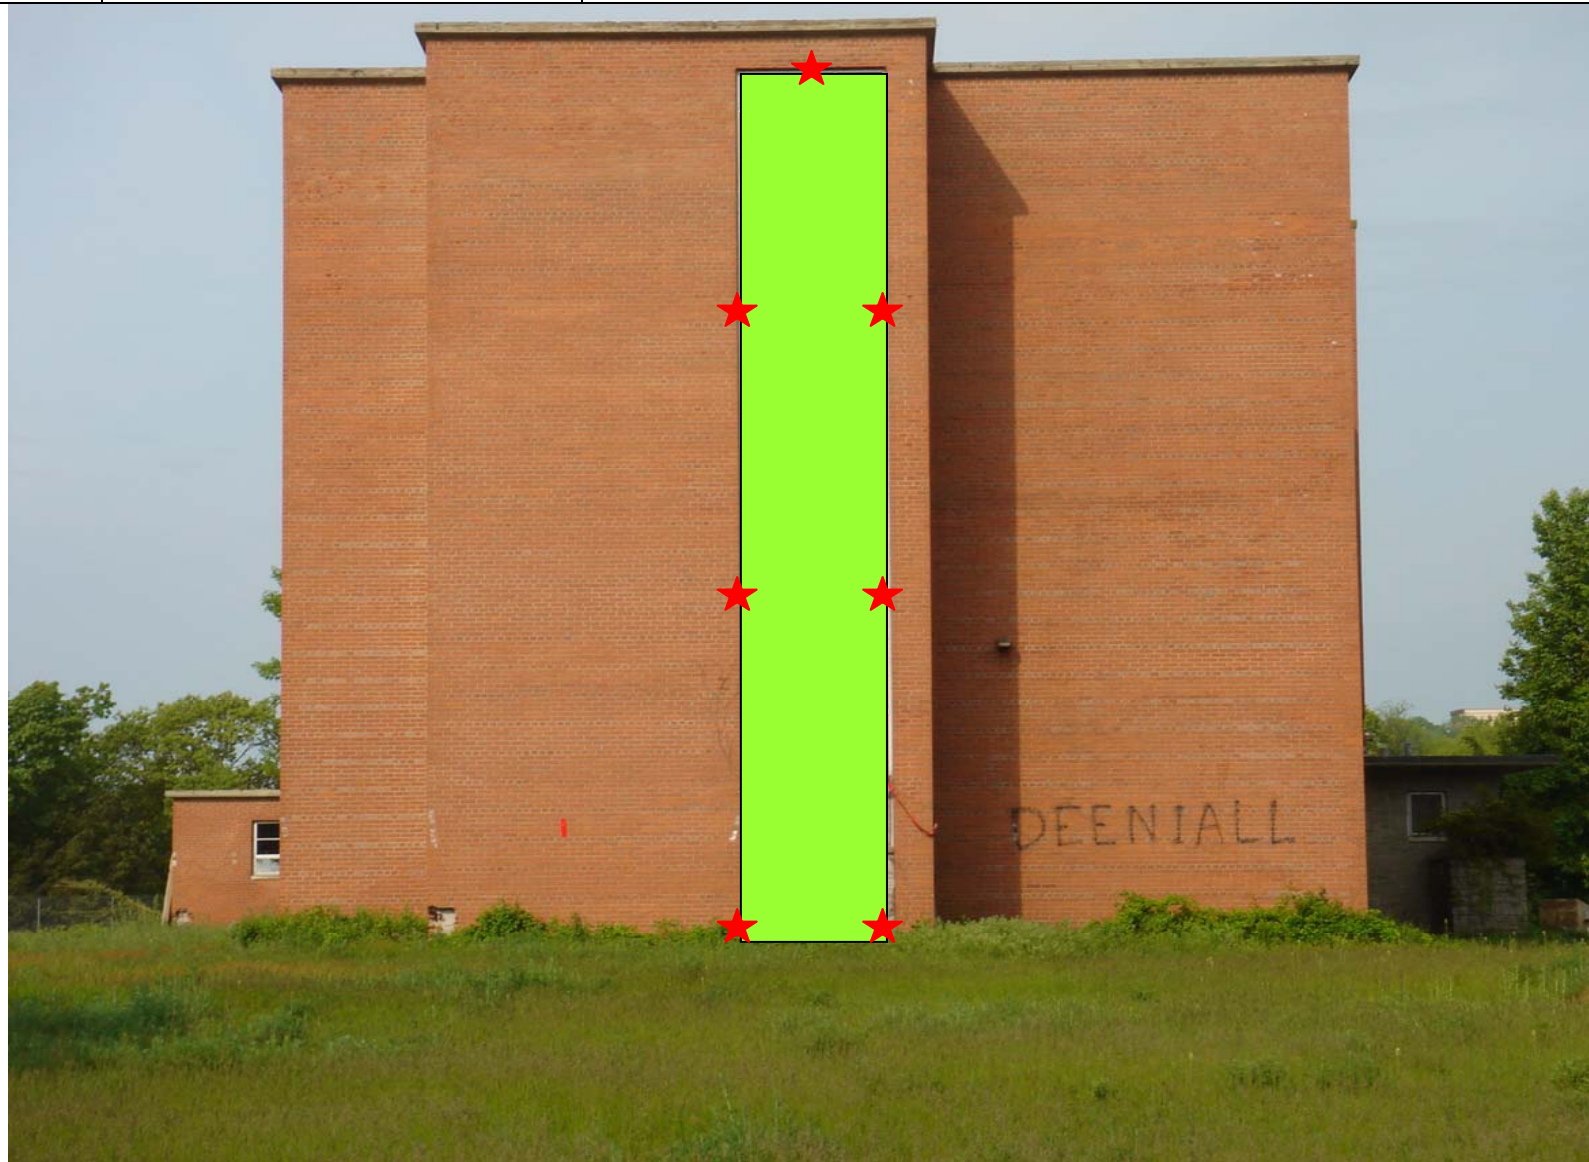
**Client Name:** Preston  
Redevelopment Agency**Site Location:** Former Norwich  
State Hospital, Ribicoff Hospital**Project No.** 250598**Photo No.**  
18 **Date:**  
June 2012**Direction Photo Taken:****East Side (Side B) of  
Building****Description:**

Proposed verification  
brick substrate sample  
locations are depicted  
as red stars.

Curtain wall type  
window systems having  
caulk less than 50 ppm  
PCBs is highlighted in  
green. Caulk to be  
disposed of as a Bulk  
Product Waste.

Caulk disposal and  
verification sampling  
will be the same on the  
west side of building  
(Side D)
